**Report on the Two Bells at  
the Parish Church of St Peter,  
Lee Brockhurst, Shropshire.  
Archdeaconry of Salop, Diocese of Lichfield.**

Peter Woollam, MSc, HND, CEng, MIET  
Lichfield DAC Bell Adviser  
23<sup>rd</sup> February 2023

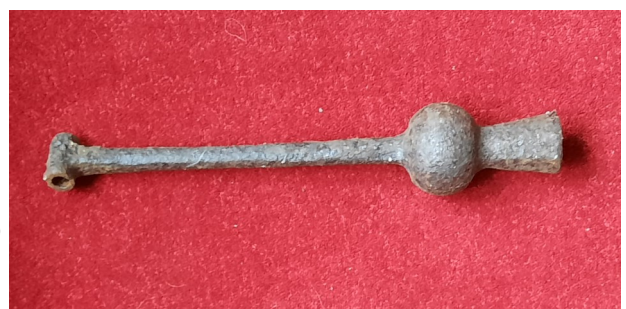
Fig. 2 (Photo by Phoebe Ashton)

The clapper of the smaller bell (Fig. 2) recently fell to the ground during ringing for a Sunday service. The church has taken this to indicate that the installation is in need of thorough examination, the likelihood that some degree of remedial work is necessary and that a Faculty will probably be required.

We know from the form of the clapper of the c.1400 bell, with its ‘closed eye’ top, (see Fig. 2) that the Victorians made changes and in Fig. 4 we see the tops of central bolts through both headstocks and bells. These features indicate that some form of assembly that included a hinge pin was introduced.

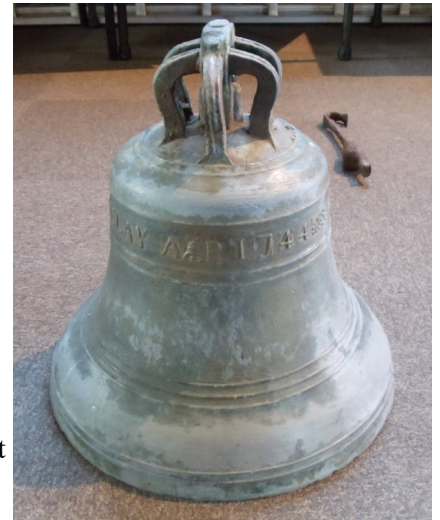
Both bells would originally have been cast with cannons – loops at the crown - by which they could be fastened with iron straps to a wooden headstock. These have been removed, almost certainly by the Victorians, a matter of extreme regret in the case of the mediaeval bell, but of relatively minor concern with the Rudhall bell.

Fig. 3 Example of a bell having its cannons intact

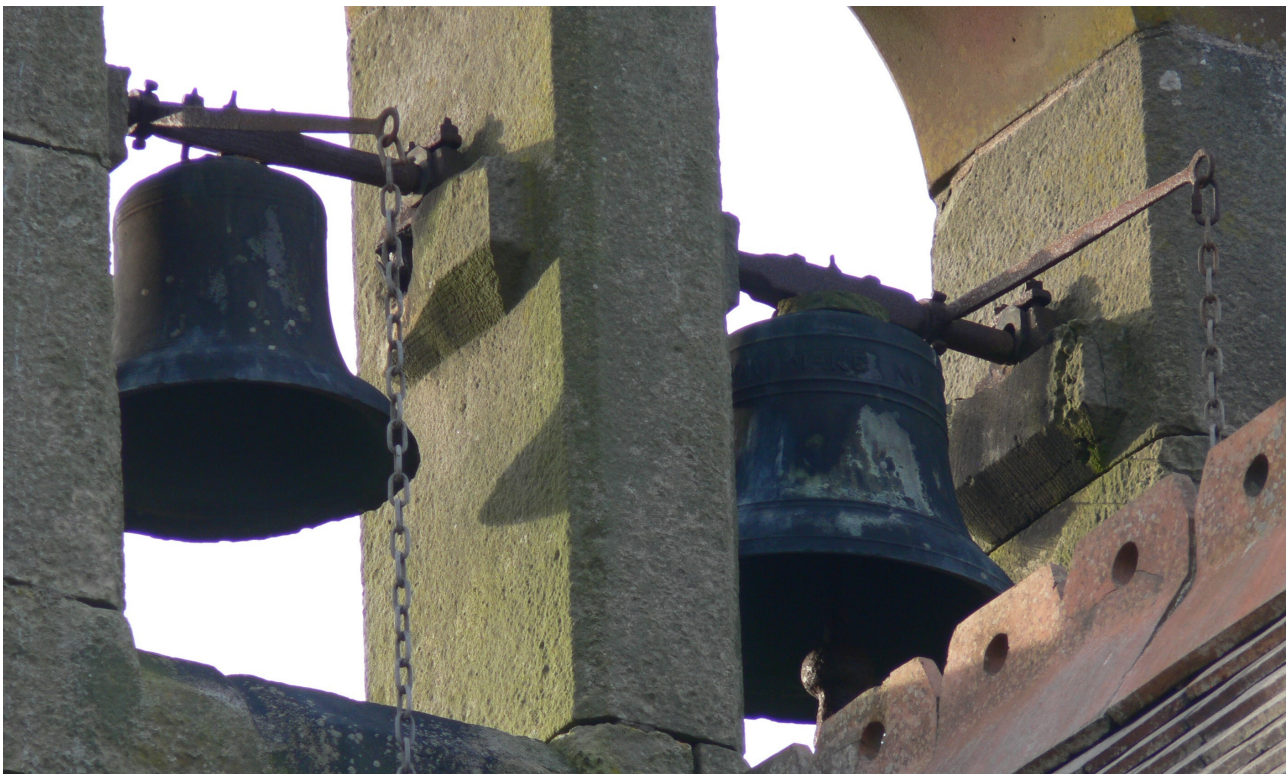
Fig. 4 The hanging arrangement

The flat-topped bells that resulted were each suspended by two bolts from their own simple wrought iron bar headstocks, supported at each end in cast iron bearing housings. These in turn rest on stone corbels built into the bellcote. The bells are rung by pulling on ropes that fall inside the west end of the nave which connect to the chains and levers visible in Fig. 4.

Attention is drawn to two areas of concern revealed in Fig. 4.

The point of entry of the end of the headstock into the bearing on the furthest right of the photograph shows a significant misalignment. This is probably the result of extreme wear of either or both the end of the headstock and/or the bearing and it leaves the bell in a somewhat perilous state. The extent of the problem is such that I have recommended immediate cessation of the ringing of this bell.

A wooden pad can be seen interposed between the top of the bell and the underside of the headstock of the Rudhall bell (on the right). This was carved on the underside to sit neatly over the irregular surface left by the removal of the cannons and present a flat horizontal surface to mate with the headstock. The corresponding wooden pad on the c.1400 bell is missing, presumed lost to decay. The resulting instability has led to the two bolts which secure the bell to the headstock bending along their unsupported length - note that the bell hangs vertically but the chiming lever is not horizontal. This bending of the bolts, together with the effects of corrosion, may have significantly reduced their strength, rendering this bell in a similarly parlous state. Given the loss of the clapper, it seems unlikely that any attempt will be made to swing the bell, but it would be prudent to place its rope out of reach.

The Victorian engineering described here has served the church well for 139 years. It has though, as we have seen, now reached the end of its useful life, and the need for a full refurbishment of the installation is indicated.

- The two bells and all of their fittings to be removed from the bellcote and taken to the contractor’s works. (This will require the erection of scaffolding fitted with a hoist capable of bearing their weight.)

- The headstocks, bell bolts and clapper suspensions to be separated from the bells and discarded.
- The bells to be cleaned and carefully inspected for any cracks. If any are found, this to be reported back to the church and further consultation to take place with the DAC over possible appropriate measures.

- The status of any remaining cast-in staple ironwork to be established. In the case of the Rudhall bell, a professional opinion to be determined over the merit of drilling out any remaining stumps or of drilling stress-relieving holes. In the case of the c.1400 bell, no such drilling to be performed, it being judged that, if corrosion of the staples has not caused cracks in the bell after 600 years, it is unlikely to do so in future.

- Cast resin pads onto the crown of each bell, these to replace the previous wooden pads.
- Provide for each bell a new headstock, complete with rolling element bearings, in either galvanised and painted mild steel, stainless steel or hardwood; the choice of material to be made by the church. The headstock of the c.1400 bell to be fixed via the two existing holes in its crown.

- Provide for each bell a new independent crown staple and a new clapper in ‘SG’ iron.
- Return the bells to the church, hoist into the bellcote and mount on the existing stone corbels, making any necessary minor modifications to the masonry. Refit or replace as necessary the chains and bell ropes to permit manual chiming.

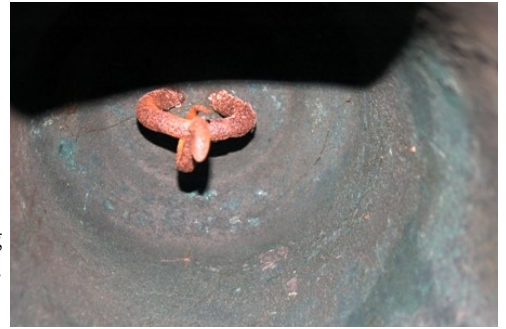
Again, when new, both bells would have been fitted with cast-in crown staples. These iron ‘rings’ were placed in the mould prior to pouring the molten bronze such that, on solidification, part of the staple was embedded in the crown and part exposed on the underside. This provided a means to suspend a clapper.

Fig. 5 Looking up inside a bell, showing an example of a cast-in crown staple.

Cast-in crown staples have a history of being troublesome. Always of iron, they corrode over a period of time. Iron oxide occupies a greater volume than the parent metal, and the expansion that accompanies corrosion is a known cause of cracks forming in the crowns of bells.

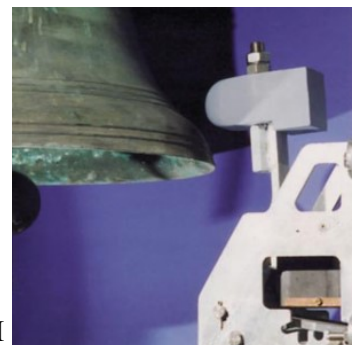
This part of the report would be incomplete if it failed to mention the possibility of dispensing with the need to pull on ropes, but instead to have the bells struck by electro-magnetic hammers (EMH), initiated by the press of a button indoors. Fig. 6 illustrates such a mechanism. In the case of large bells, the hammers can be concealed inside the bells themselves, but those at St Peter’s will not permit this. The hammers would be readily visible, something which would be widely regarded as unacceptable as it would have a detrimental impact on the appearance of the church. The granting of a Faculty to permit this would therefore be unlikely.

Fig. 6 Example of an externally mounted EMH
